Cruise: MGL0903

Vessel: RV Marcus Langseth (LDEO)

**RV Marcus Langseth**

#### Summary:

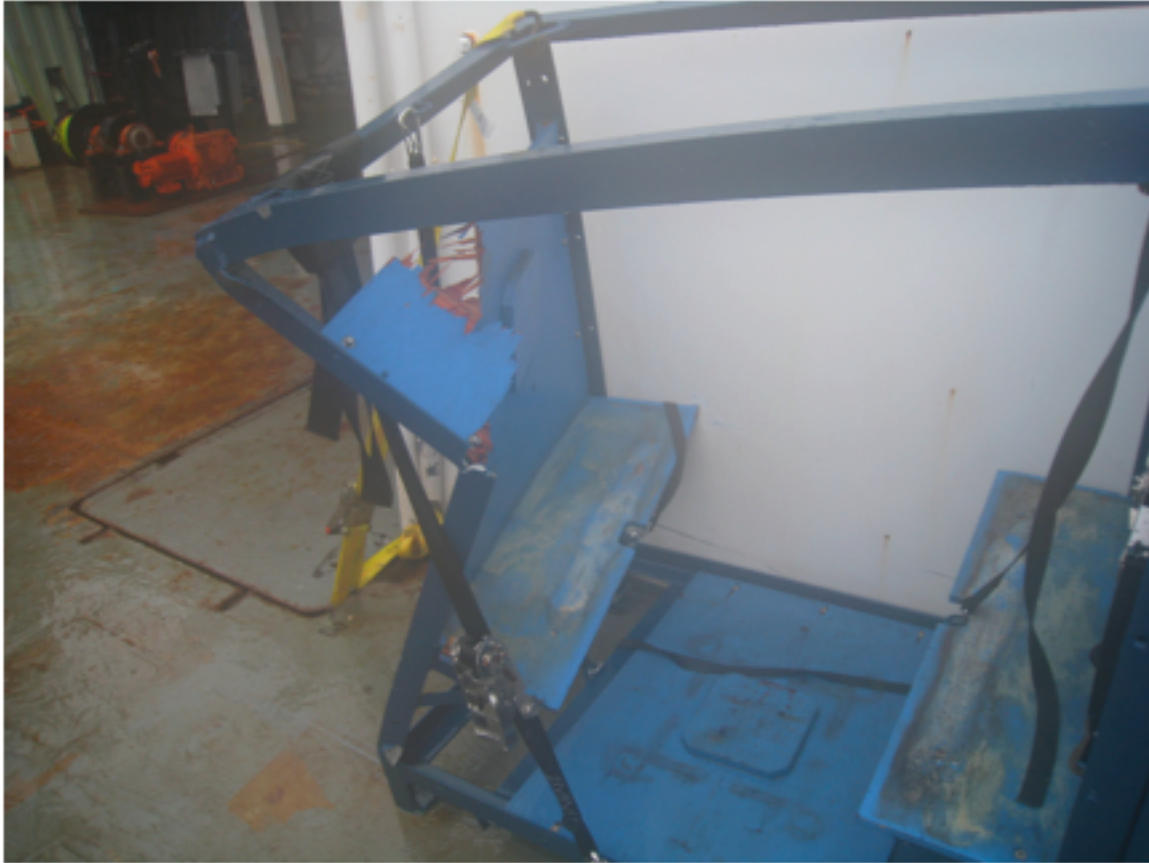
- One of the first problems we encountered during deployments was the amount of water the deck of the Langseth took on during slightly heavy seas.

The water that came over was enough to completely destroy the float racks we had secured along the main deck. In addition to the fact that every once in a while there was enough water to come and sweep people to the ground. This happened to both Crispan and Martin on separate occasions. The seas were not rough enough to stop operation but the way the deck took on water made it to be quite dangerous at times. In another incident the water came onboard and swept a float unit into the side of the WHOI van and shattered a glass ball.
