Cruise: RAINBOW (MGL1305)

SIO Purpose: Deploy 46 OBS, Recover 46 OBS, Deploy 15 OBS

Vessel: M/V Marcus G Langseth

Cruise Dates: 04/11/13 – 05/21/13

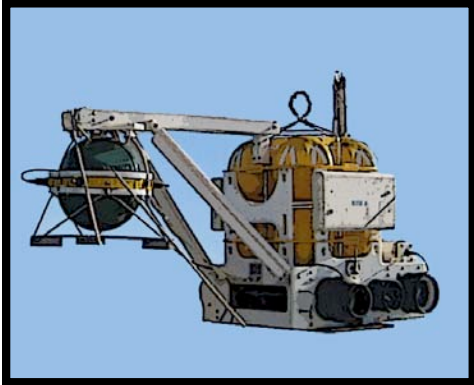
Scripps provided 10 modified long period LC4X4s for this experiment. The sensors associated with these instruments are L22 single channel geophone and a hydrophone. Each instrument consists of a 160# anchor and an eight glass-ball McLane float assembly. The polyethylene frame holds the acoustic release transponder the data logger, the battery bottle, and a dual mechanical release system.

After the anchor is released for recovery, this instrument will ascend at more than 50 m/min. To increase visibility once at the surface, an orange flag on a 48" fiberglass staff is attached to the lift bale. Also, a Novatech low-pressure activated strobe-beacon and radio

are mounted near the base of the flag on the lift bale. The radio operates at 160.725 MHz.

The acoustic release transponder developed in conjunction with ORE/EdgeTech is interrogated at 11kHz and responds at 13kHz. Alkaline batteries provide 18 volts power for the burn, 12 volts power for the transponder, and 9 volts power for the circuit board logic. The release mechanism includes two double wire burn elements. When fresh, two battery strings are combined to provide the 18 volts to burn one of two release wires in an average of 7-minutes for water depths encountered during this experiment.

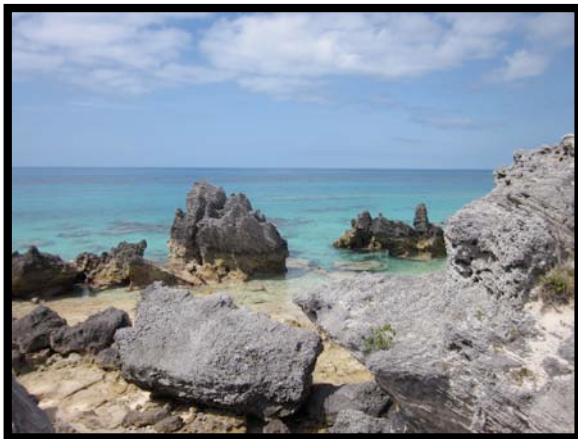
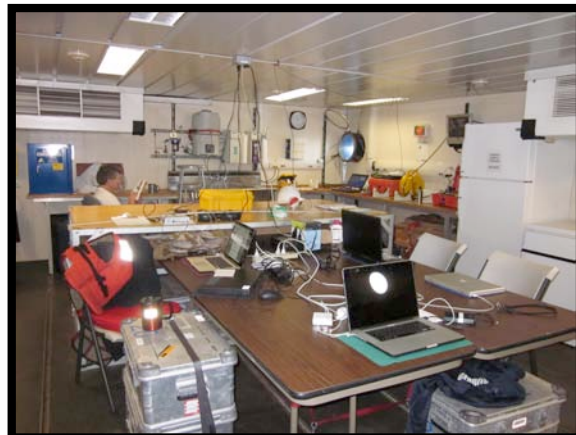
We arrived in Bermuda on the afternoon of the 7th and the Langseth arrived the morning of the 8th. We spent the day reorganizing our gear, setting up the lab and testing the new logger electronics and ships transducer connection.

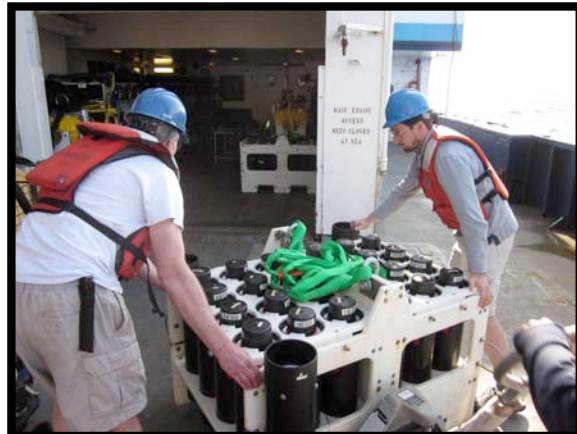
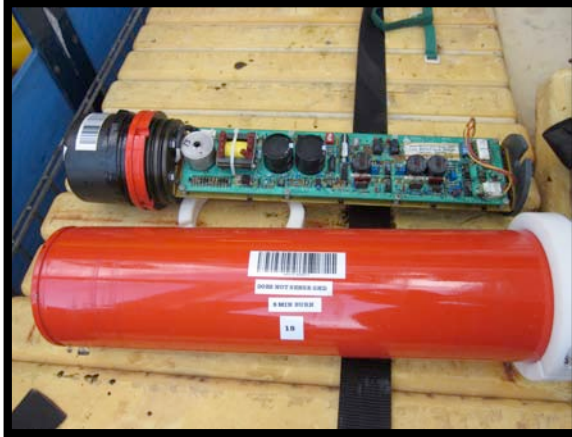
We have two acoustic units that will not talk to us (15 & 88). We had the rosette retrieved to 2000M and no still luck; we then came up to 1000M and no luck. All other acoustics are talking loud and clear.

We asked for the rosette to be brought to the surface, so that we can inspect the two faulty acoustic units.

After inspection in the lab we found that acoustic #15 had flooded at the ducer face seal where there is one o-ring sealing it to the mounting plate. All of the electronics were ruined. The pressure from the alkaline/seawater reaction was

great enough to blow the head off as I separated the poly split-ring spacer. It shot halfway out of the tube and puked black acrid water on the floor. Luckily no one was in the path of the splash. The battery pack was hot, so it was jettisoned.

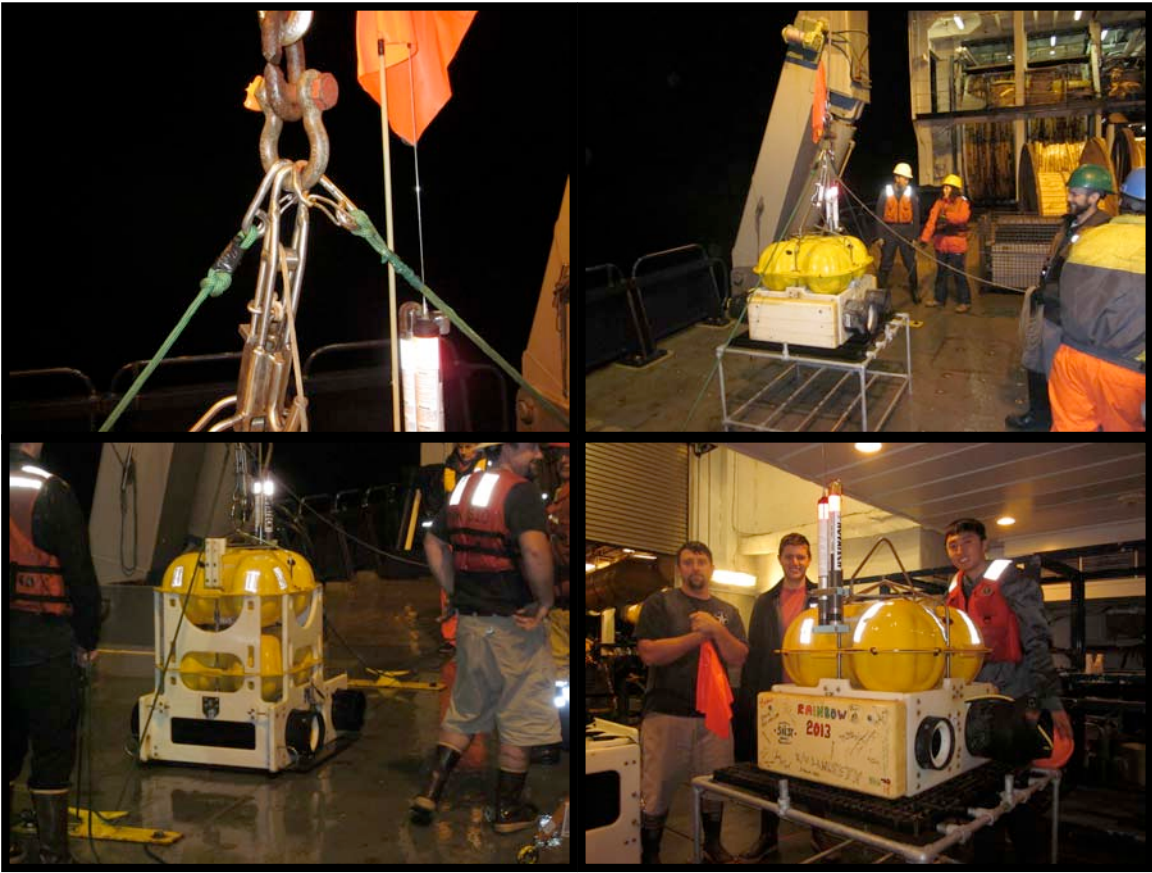
The new SP launch/recovery table has been working great although it can slide a little on the pallet-jack forks in rough seas, so I'll need to add some antiskid below the lower rack, or to the surface of our pallet jacks.

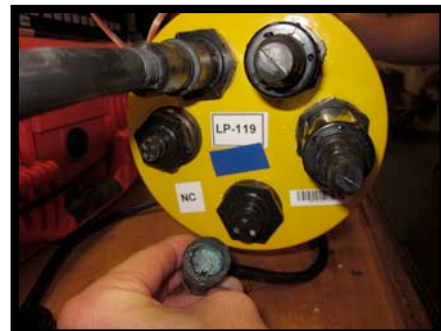
Site OBS04 recovery went as anticipated. The instrument ascended at a rate near 75 meters/min because of all of the additional flotation, being a converted LP unit. The unfortunate discovery identified upon securing the OBS on deck was that the run-plug had been knocked askew during the deployment operation. This allowed seawater to enter the 3-pin HPD and short out the batteries. Fortunately

the logger did not flood. The instrument recorded for ~15 hours before the batteries died.

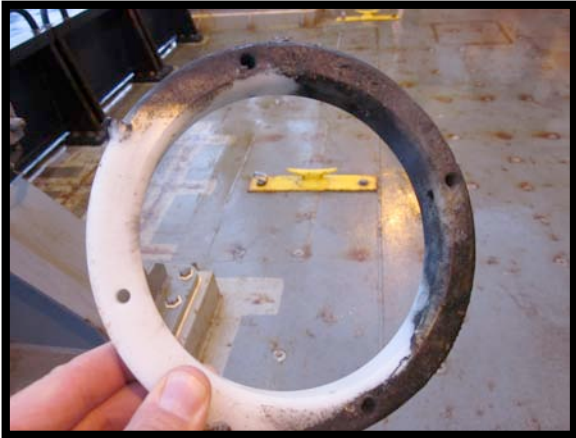
Site OBS42 has a flooded logger, which was identified at recovery. The lithium reaction was finished as far as I could tell, so we were able to recover the instrument, unbolt the retaining rings and then jettison the logger (13009) overboard. There was nothing in the logger worth salvaging and opening it was too dangerous to consider. The black mess flushing out of the logger was acrid and irritating to the skin, so we got the mess cleaned up as quickly and safely as possible. The logger appeared to have reacted from the back end cap, which Phil noted

had no seal screws, so it must have leaked from the rear bore seals. Aside from the logger and data loss, all other components of this OBS were saved.

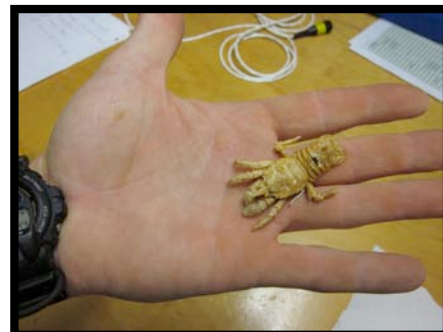
Site OBS16 we recovered a small white'ish crayfish looking crustacean that likely lives on, or near a black smoker (hydrothermal vent). This means that we were pretty damn close to a vent and are lucky we didn't suffer any damage.

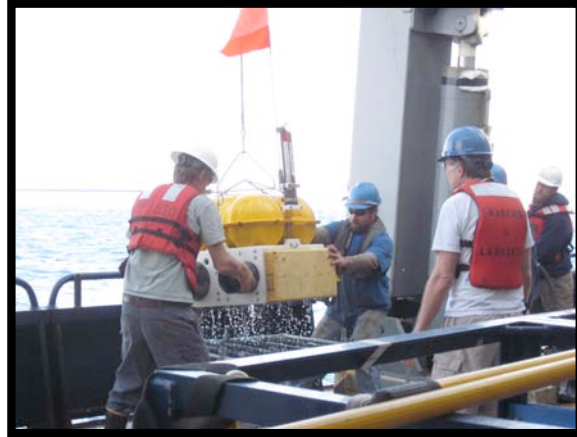
Site OBS19 had a leaked alkaline cell in the NovaTech radio, which killed it. There was no water intrusion. On a different site when one of the NoveTechs were being installed it must have hung up on the polly mounting bracket and the installer must have twisted it (rotated) to get it to slide all the way down. The problem was that it was rotated counterclockwise and the switch-base was unscrewed a half turn from the body and it caused the unit to leak. If it had been twisted clockwise it would have been fine.

The instrument at site OBS22 had acoustic #94 inside, which is a 5-minute burn cycle unit. The OBS released from its anchor within the 5-minute burn window. Inspection of the mechanical release after recovery revealed that the burn wire was the single thread type, which are the newer ones we have recently switched to in hopes of shortening the release times from the anchor, or in the case of a faltering battery pack, a shorter amount of time spent coaxing it off the bottom.

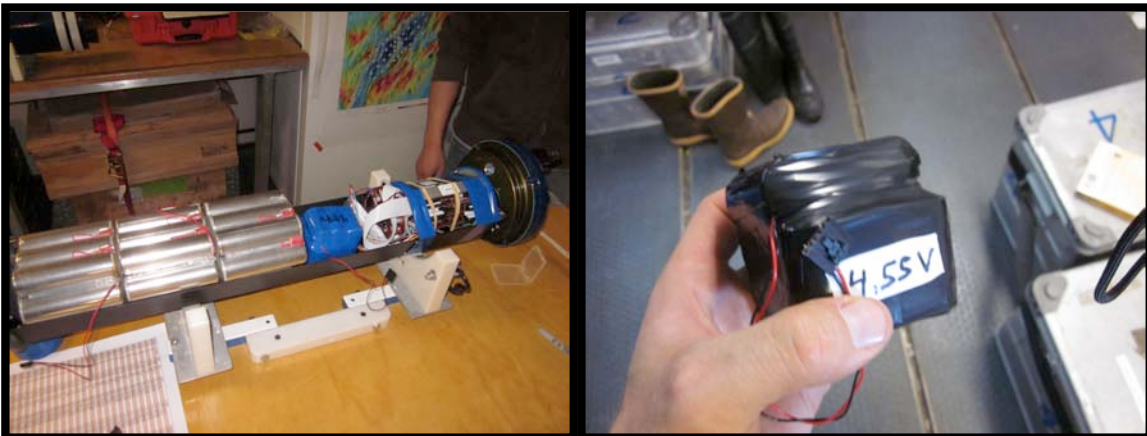
The eight lithium powered loggers, which are to be deployed after we finish the

alkaline SP recoveries, are setup and ready to go. We made two clock battery backup packs by soldering four of the 3-C cell alkaline packs together, in parallel. This should be enough amp hours to support the clocks for more than three months.

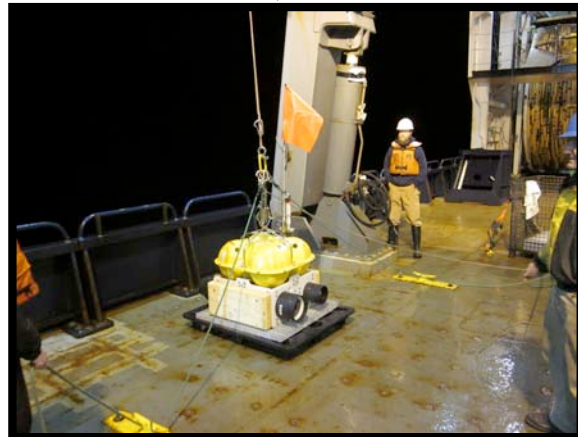
The instrument prepped for site OBS59 originally had acoustic #55, which was replaced with acoustic #65 because acoustic #55 displayed an erratic, broken sound from the ITC 3013 transducer head- possibly an issue with the ceramic.

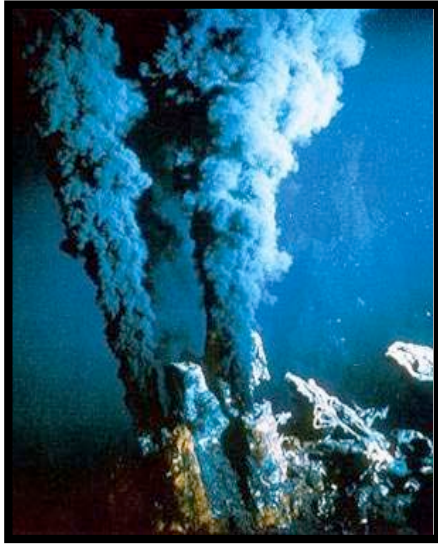
Example of a Mid-Atlantic Ridge hydrothermal vent
